CALLEGUAS CREEK

Flood Zone 3

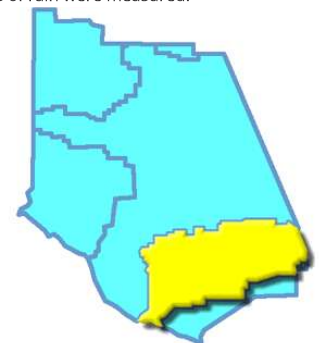
Calleguas Creek Watershed - Zone 3 (yellow)
